STRESS CORROSION CRACKING OF ROCK BOLTS

Erwin Gamboa

A THESIS SUBMITTED TO THE UNIVERSITY OF QUEENSLAND
FOR THE DEGREE OF DOCTOR OF PHILOSOPHY

NOVEMBER 2004

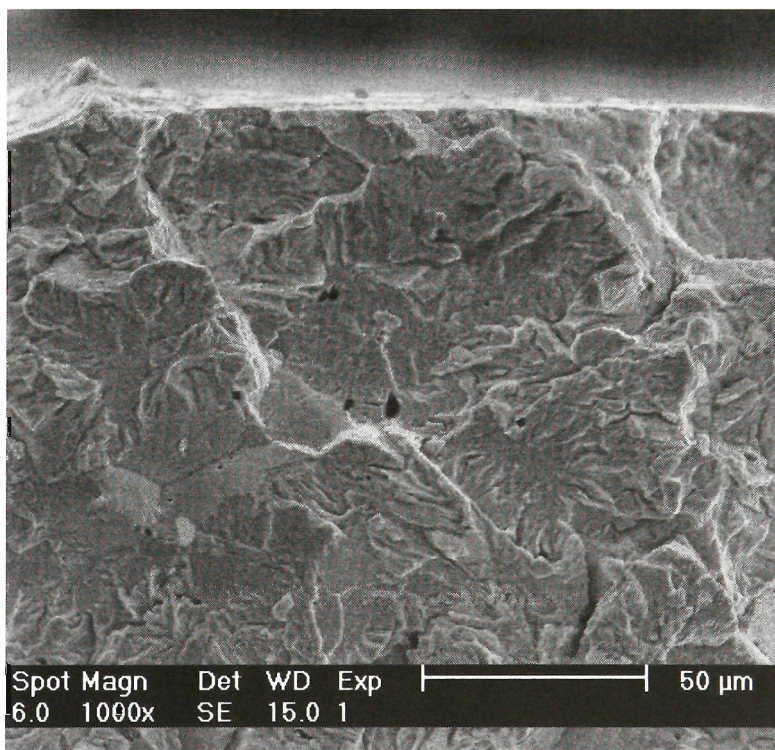
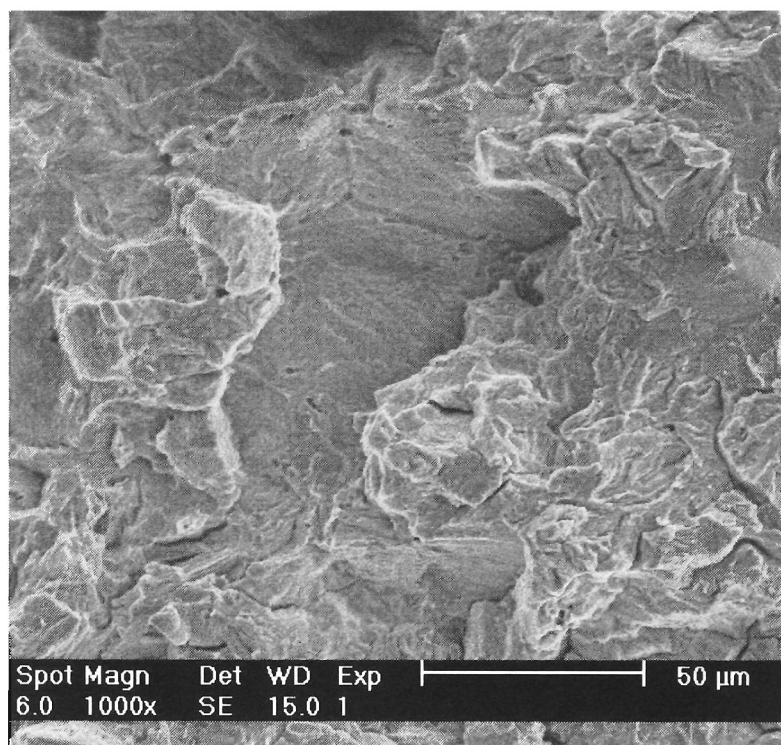
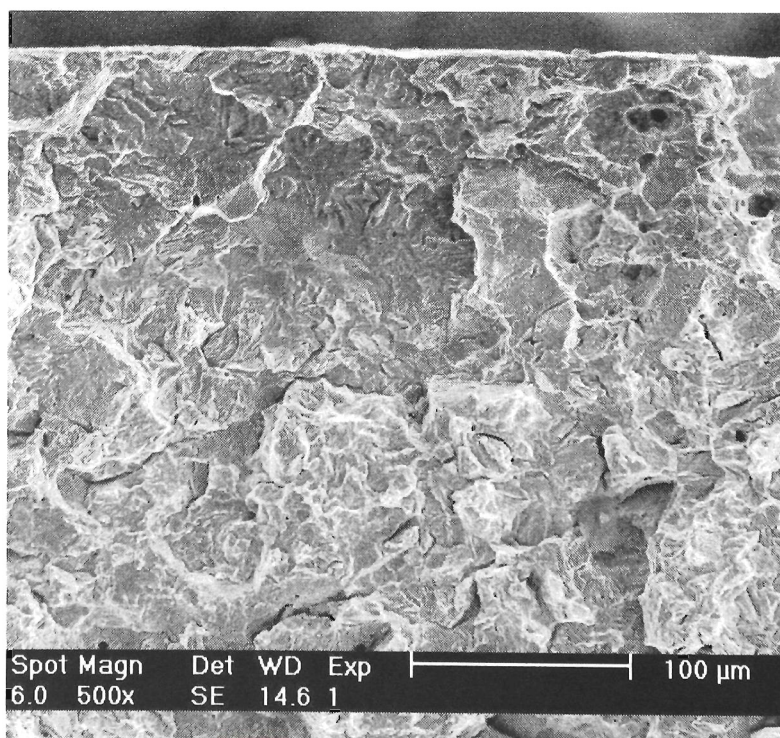
Figures 6.47, 6.48 and 6.49 show areas close to the free surface of the samples, where the fracture was typical of TTS. There were no large pits present, and the surfaces had a relief that tended to have an orientation that pointed towards the free surface of the sample.

FIGURE 6.47: TTS on a LIST sample.

FIGURE 6.48: TTS further away from the free surface.

FIGURE 6.49: TTS at a different site within sample LIST39.

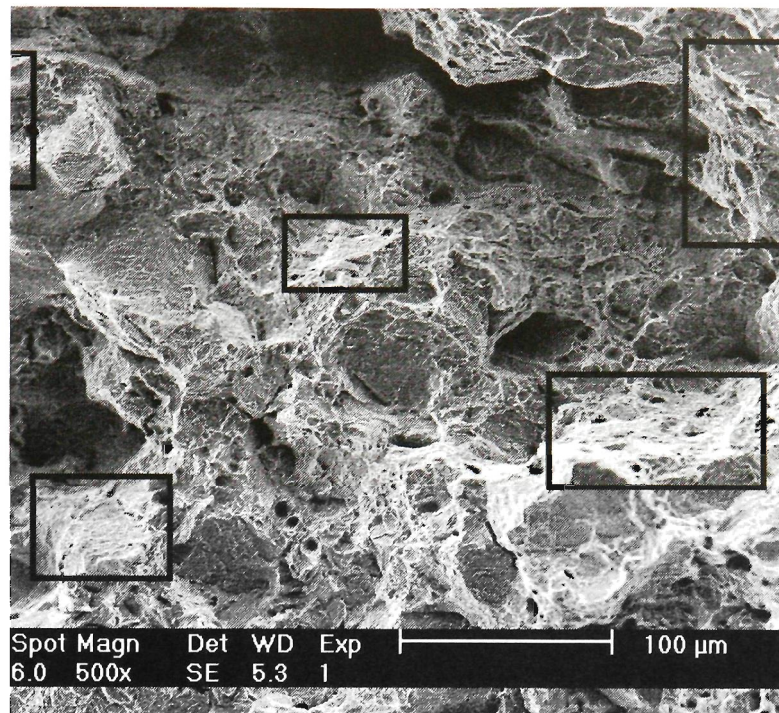
Two different kinds of slopes were identified. One was a corrugated, relatively even slope (as shown by the rectangles in Figure 6.50). The other kind was a dimpled surface, irregular and suggests ductile tearing (as shown by the rectangles in Figure 6.51). It is postulated that the first of these slopes was produced by the crack tip advancing at an angle through the pearlite colony. The smoother these surfaces appear, the closer the angle of crack growth along the pearlite grain's main axis.

FIGURE 6.50: Corrugated relatively even slope within SCC region.

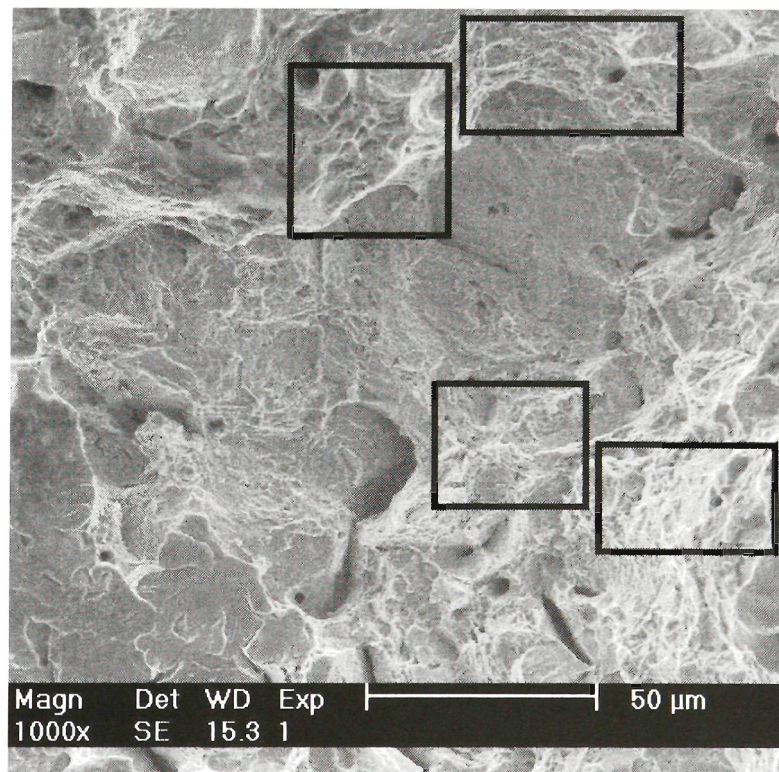
FIGURE 6.51: Dimpled irregular surface within SCC region.

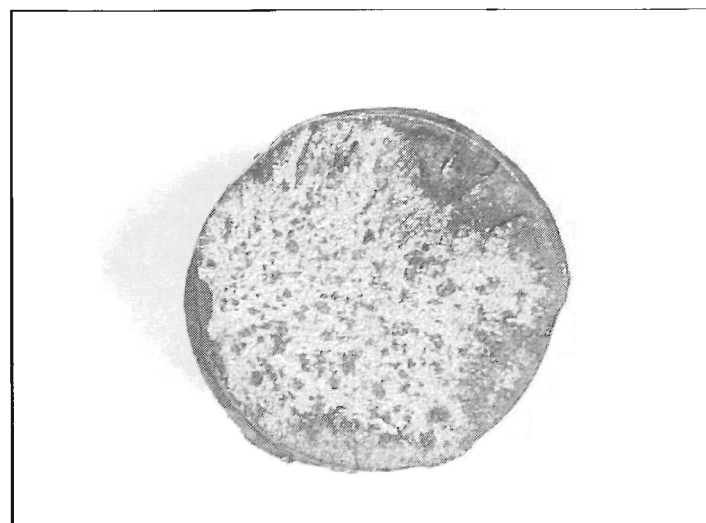
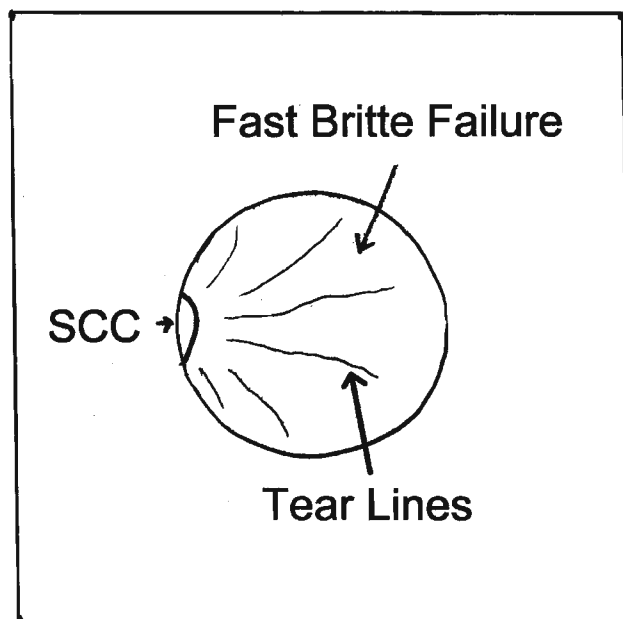
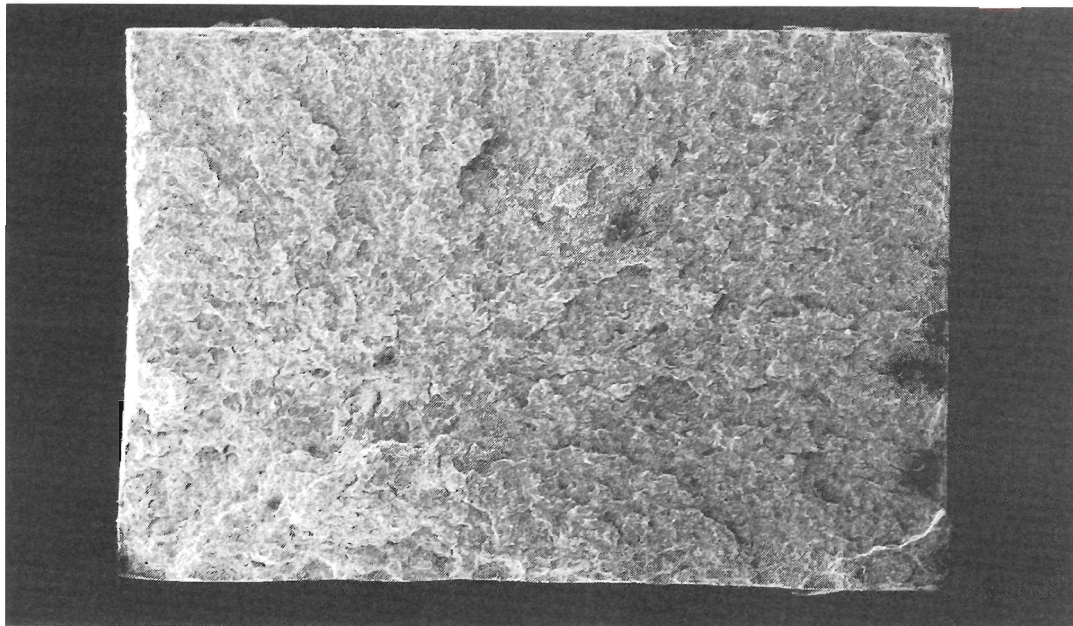
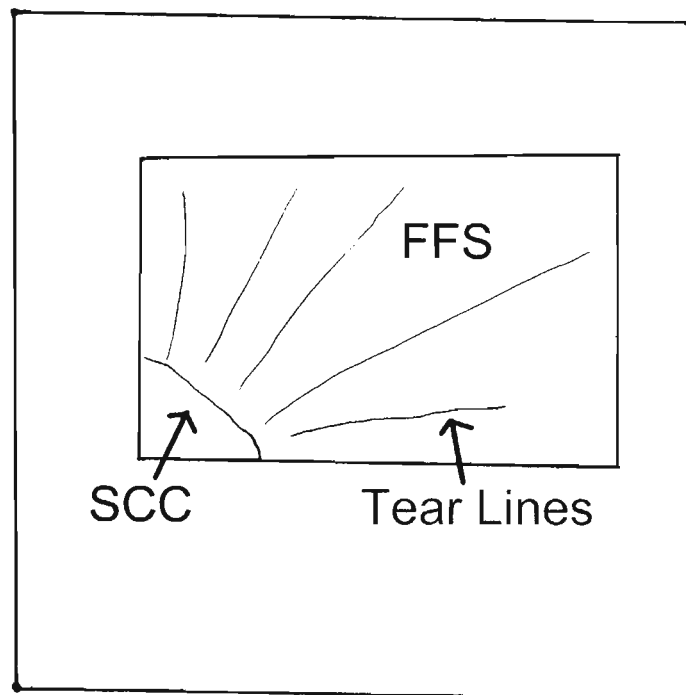
A direct comparison of a service fracture and a LIST fracture is provided in Figure 6.52. Again, there was the SCC region and the brittle fast fracture (FF) of the overload region. These regions are identified in the schematics of Figures 6.52(b) and 6.52(d). It is worth noting that the fracture surfaces are macroscopically brittle with little indications of any macroscopic ductility.

(a) Typical service failure

(b) Schematic of Figure 6.52(a)

(c) LIST sample with SCC

(d) Schematic of Figure 6.52(c)

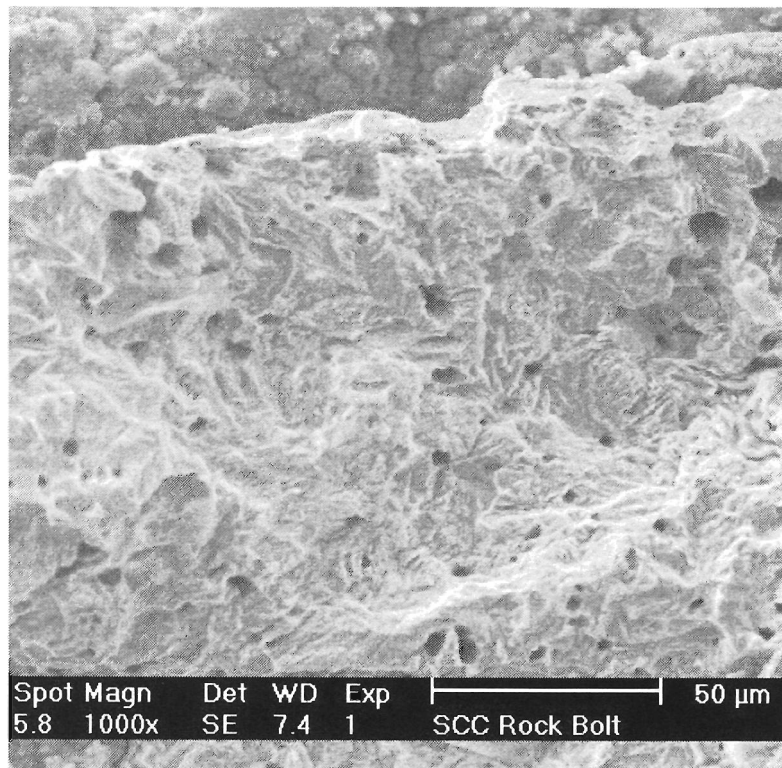
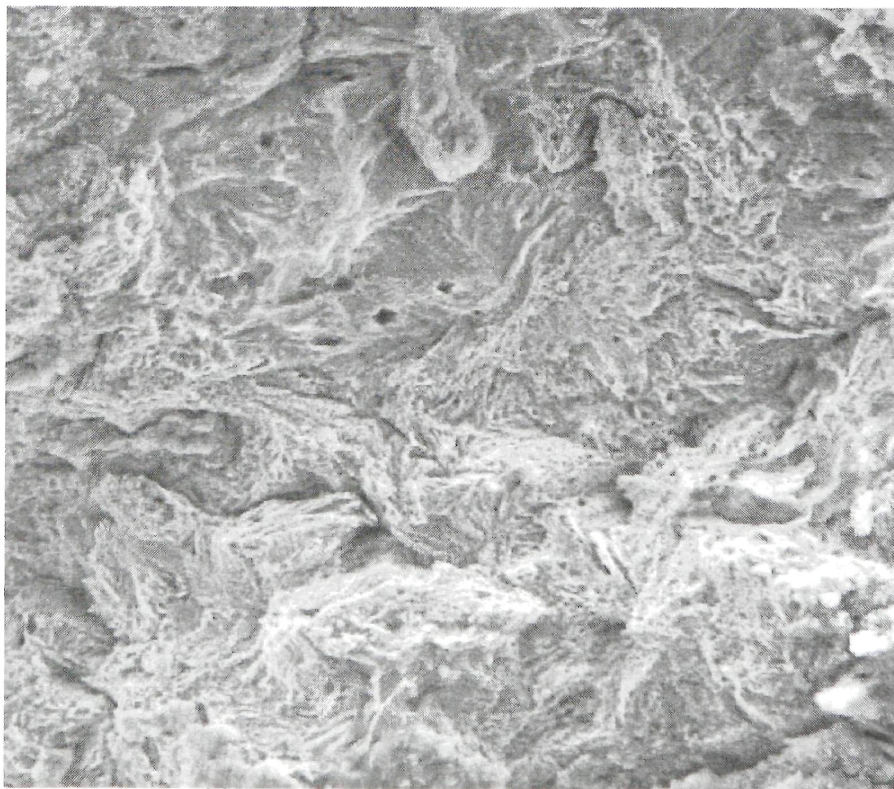
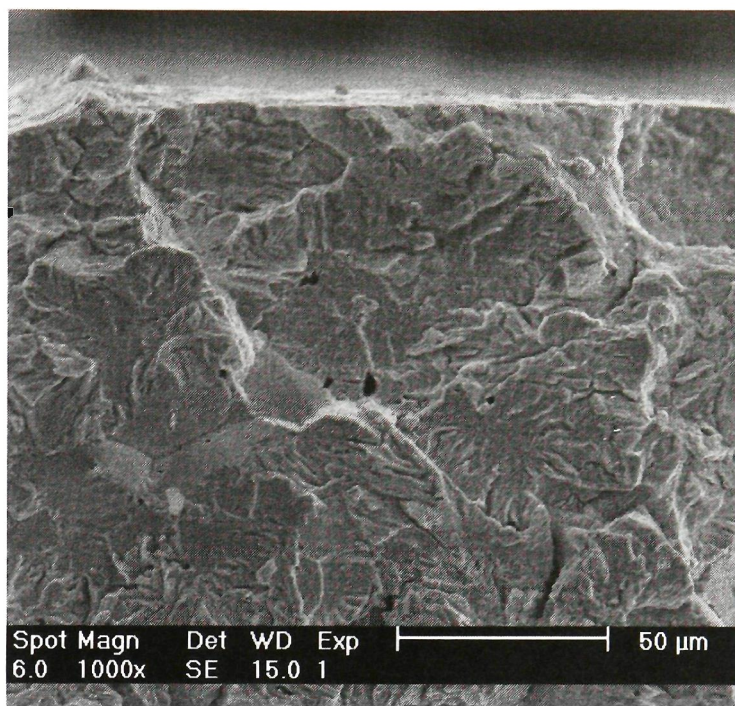
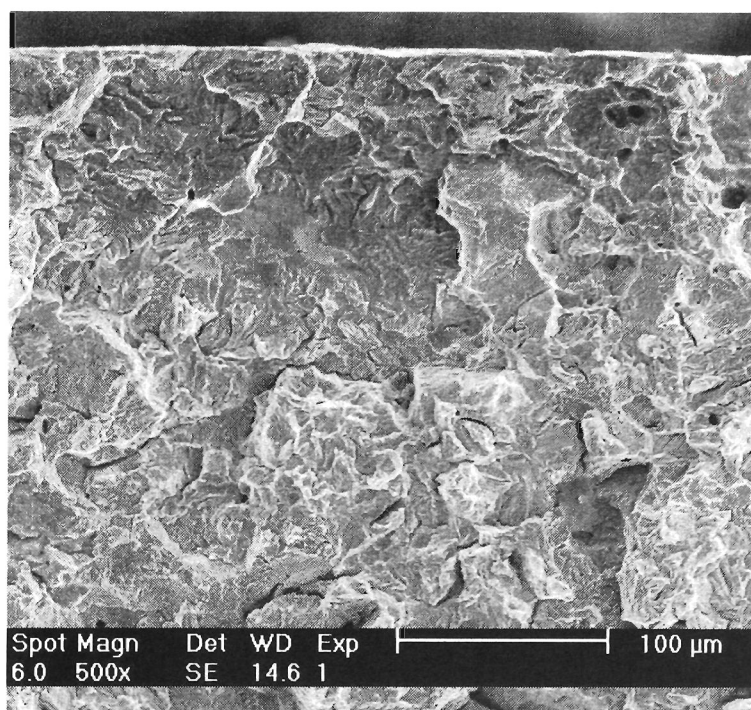
Typical TTS morphologies for rock bolts are presented in Figures 6.53(a) and 6.53(b) to allow comparison of typical TTS morphologies from LIST samples in Figures 6.53(c) and 6.53(d). The tearing topography surface was characterised by a flat convoluted surface with tiny ridges apparently oriented randomly. TTS typically occurred close to the free surface and consequently was associated with the early stages of SCC.

three distinct fracture morphologies: Tearing Topography Surface (TTS), Corrugated Irregular Slopes (CIS), and quasi Micro Void Coalescence (qMVC). TTS was found close to the specimen surface, Figure 6.53, which was interpreted as indicating that TTS occurred during the early stages of SCC, and its occurrence may be associated with higher availability of hydrogen. CIS occurred subsequently, and made up the majority of the SCC fracture region. At the SCC-FF interface, there was often qMVC. This qMVC may be part of the slow SCC process or may represent material where some hydrogen had diffused and consequently could fail in a qMVC mode during the fast fracture event.

(a) TTS observed within a rock bolt SCC region

(b) TTS observed within a rock bolt SCC region

(c) TTS observed within a LIST SCC region

(d) TTS observed within a LIST SCC region

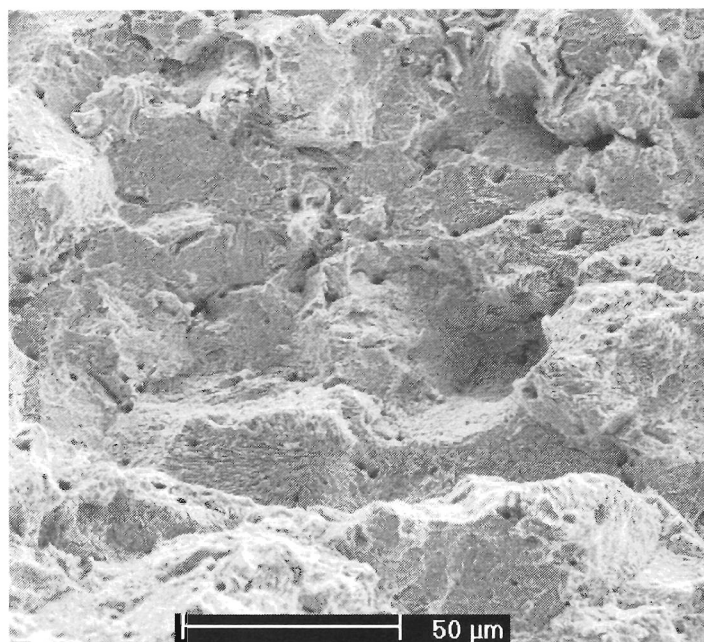
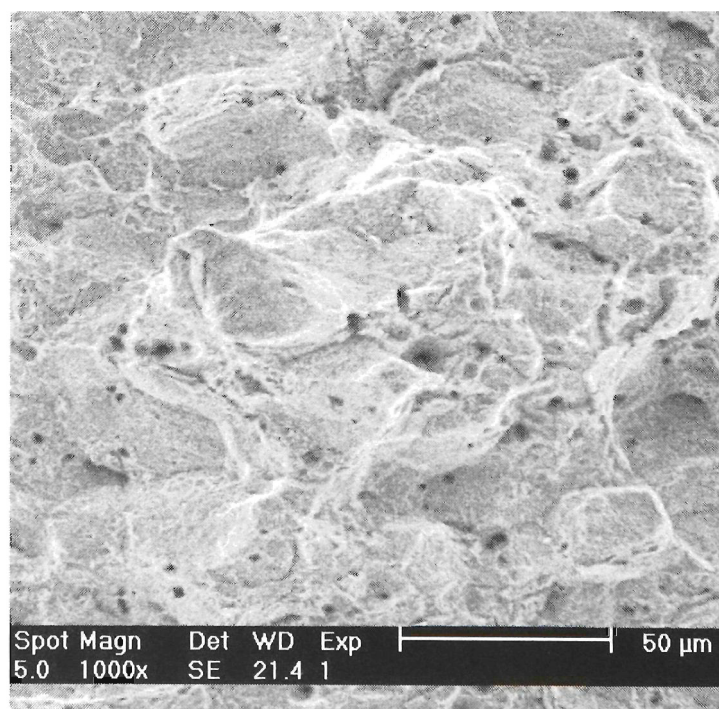
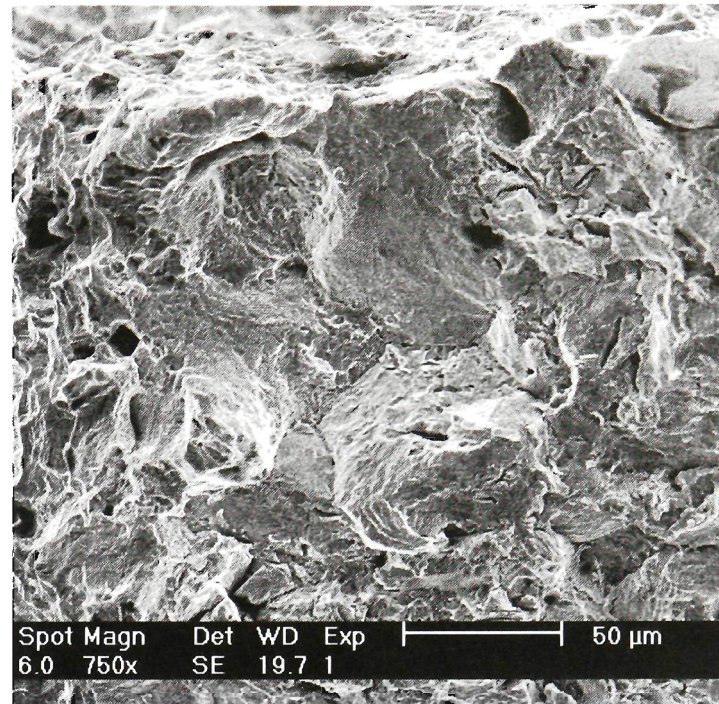
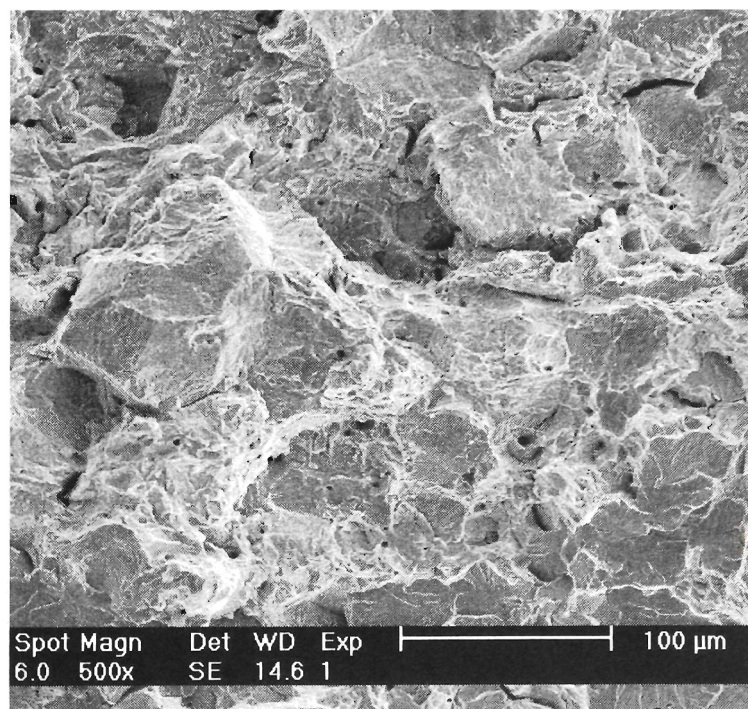
Typical CIS morphologies for rock bolts are presented in Figures 6.54(a) and 6.54(b) to allow comparison of typical morphologies from LIST samples in Figures 6.54(c) and 6.54(d). The CIS surface was characterised by flat plateaus separated by corrugated slopes.

(a) CIS observed within a rock bolt SCC region

(b) CIS observed within a rock bolt SCC region

(c) CIS observed within a LiST SCC region

(d) CIS observed within a LiST SCC region

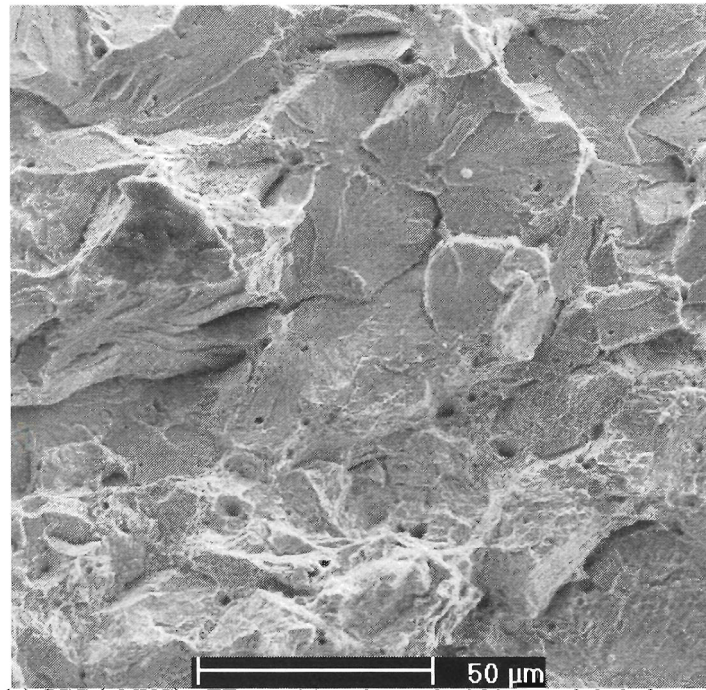
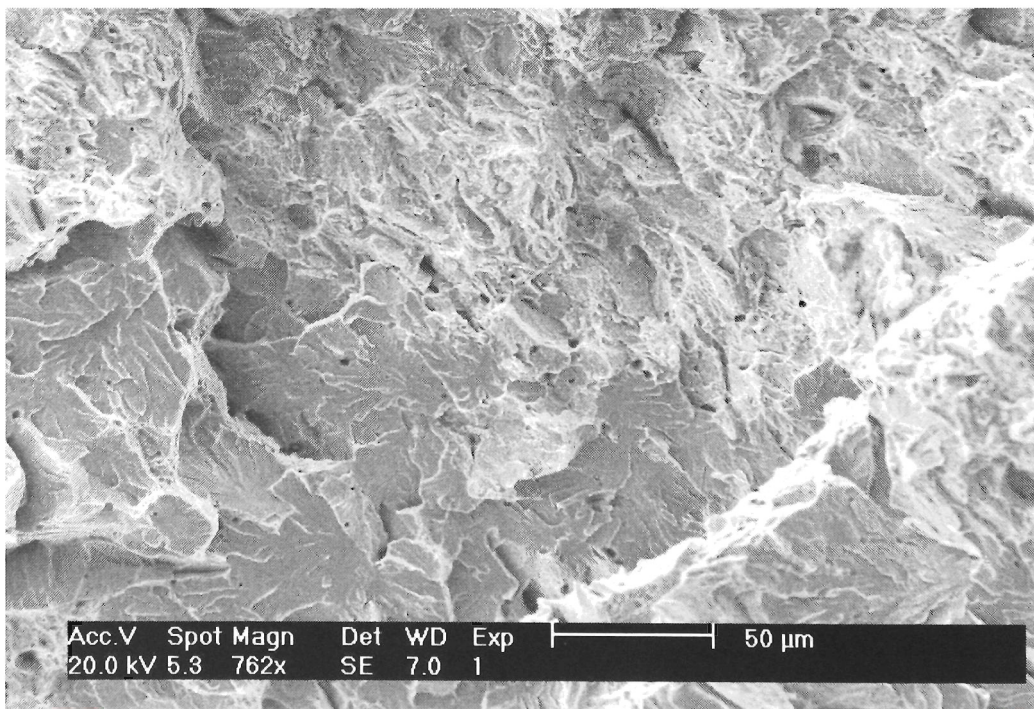
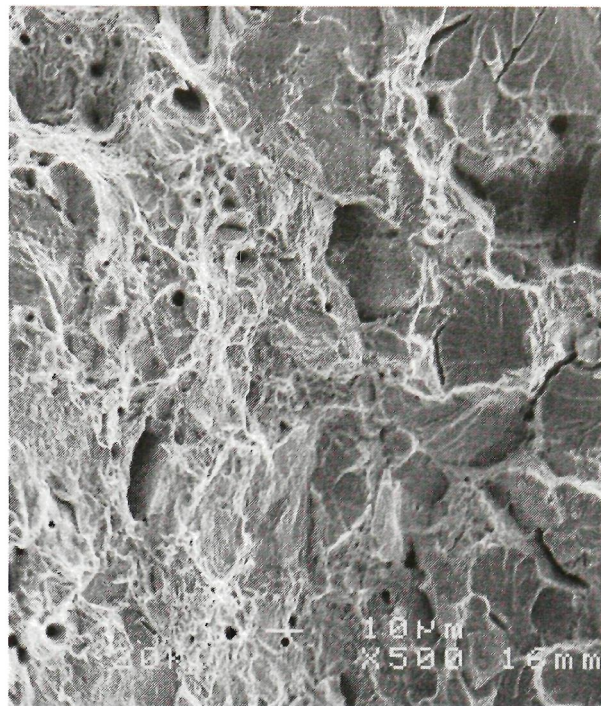
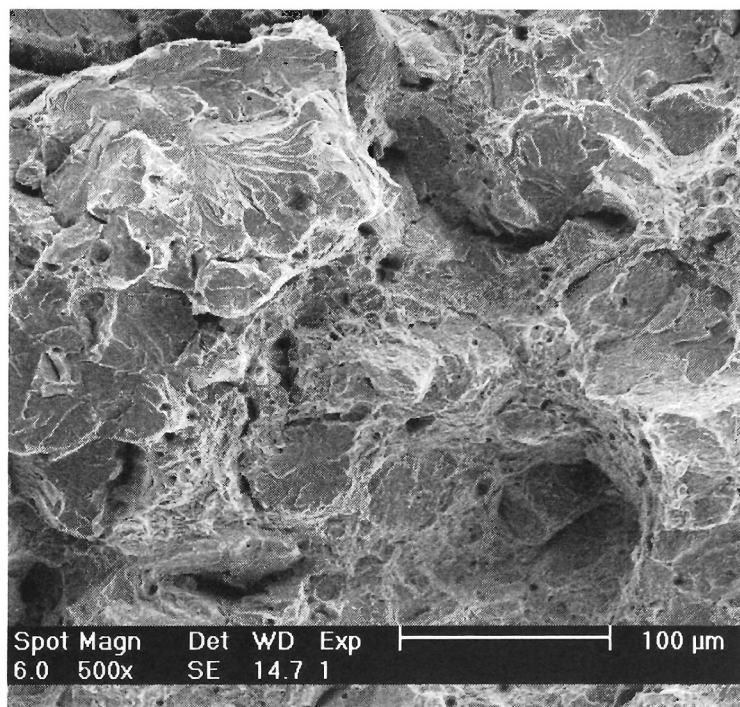
Typical morphologies for the qMVC-FF transition for rock bolts are presented in Figures 6.55(a) and 6.55(b) to allow comparison of typical morphologies from LIST samples in Figure 6.55(c) and 6.55(d). The qMVC within the SCC region was significantly flatter than the dimple rupture observed in the overload region of tensile samples without SCC.

(a) SCC (qMVC) - FF transition observed within a rock bolt fracture surface

(b) SCC (qMVC) - FF transition observed within a rock bolt fracture surface

(c) SCC (qMVC) - FF transition observed within a LIST fracture surface

(d) SCC (qMVC) - FF transition observed within a LIST fracture surface

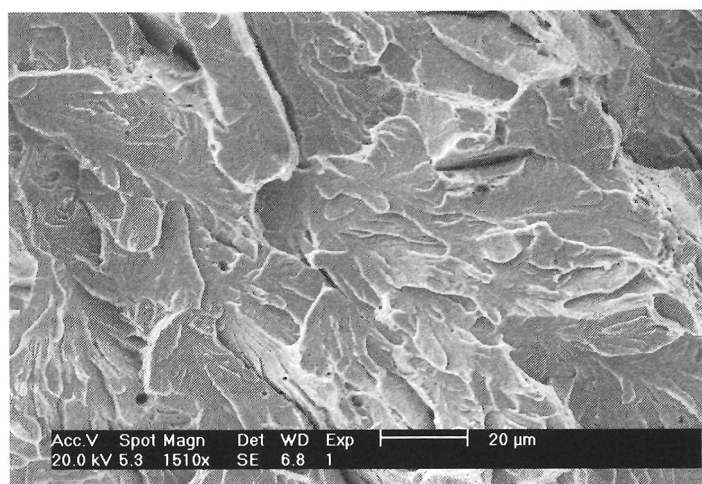
(a) FF (cleavage) observed within a rock bolt fracture surface

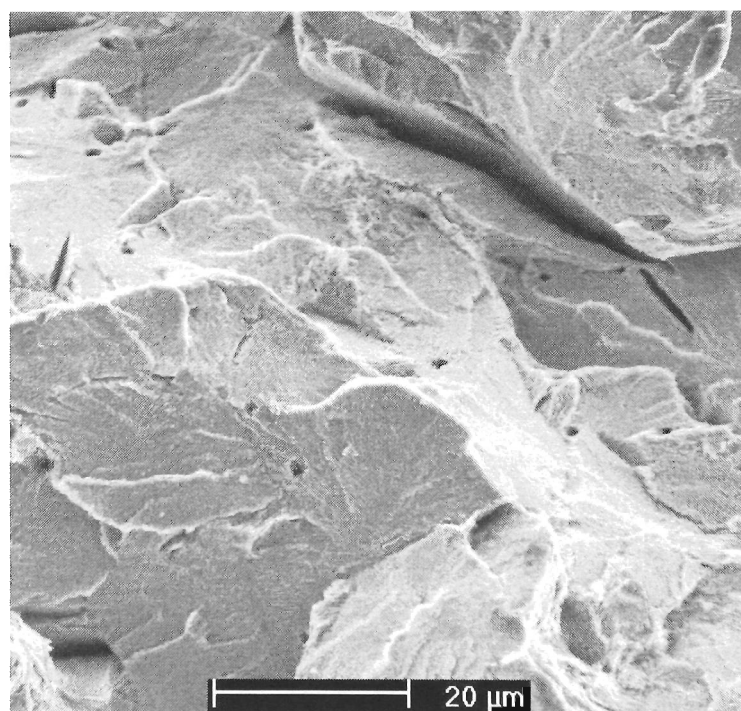
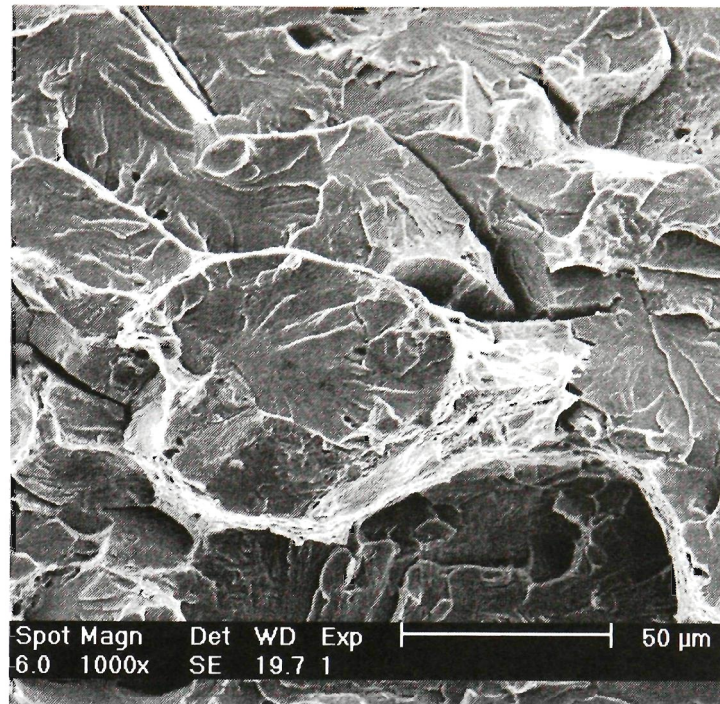
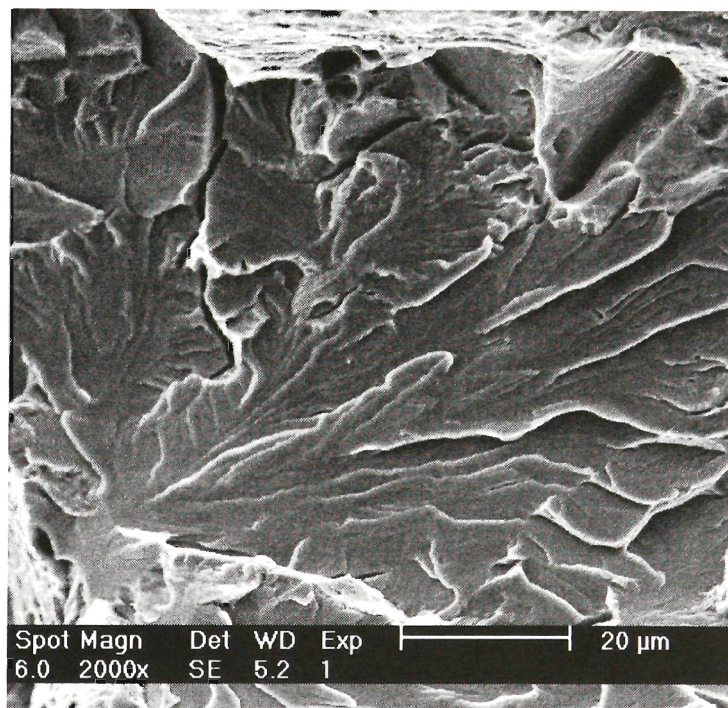
FIGURE 6.56: FF comparison

(b) FF (cleavage) observed within a rock bolt fracture surface

(c) FF (cleavage) observed within a LIST fracture surface

(d) FF (cleavage) observed within a LIST fracture surface

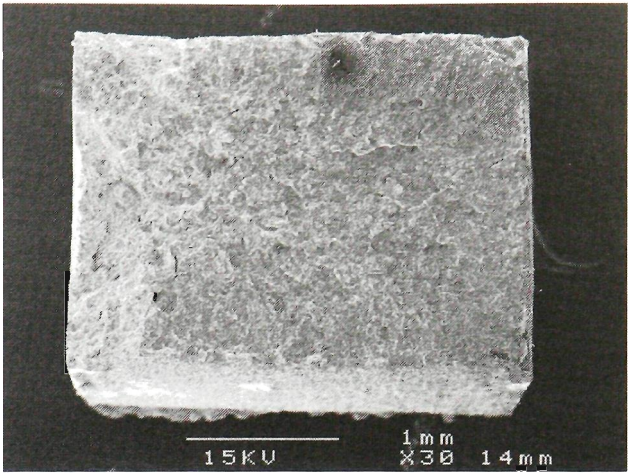
FIGURE 7.2: LIST63 (922MPa) overview

Figure 7.2 shows the slow crack region to have penetrated 0.5 mm into the sample LIST 63. LIST 63 was a 1355AXRC sample that was stressed at 0.019 MPa s^{-1} up to 922 MPa, then held until it fractured 19140 seconds later (5.3 hrs). For the crack velocity calculation it was assumed that the crack initiated when the stress on the sample reached 922 MPa and grew steadily until it reached a critical size (0.5 mm). SCC velocities v_1 and v_2 were calculated from LIST 63 and LIST 24 using Equation 7.6 to give:

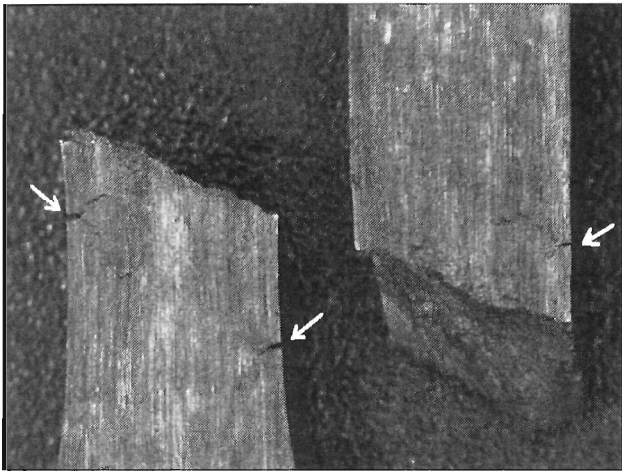
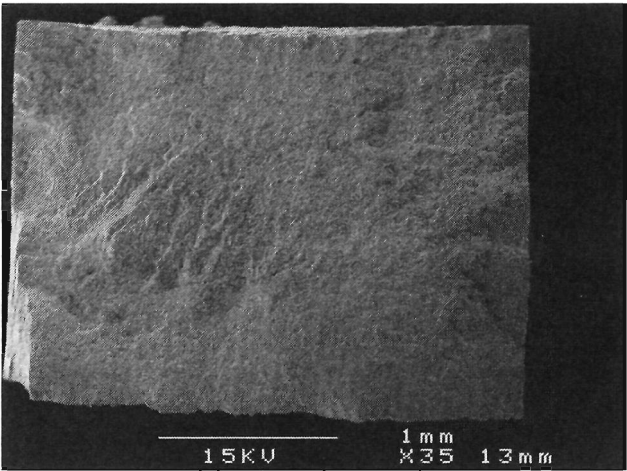
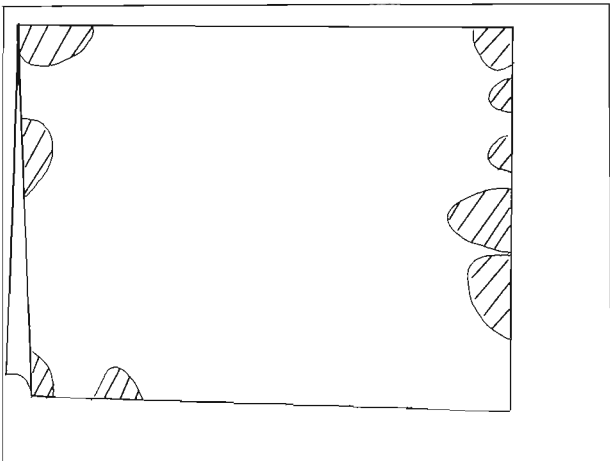
FIGURE 7.3: MAC samples failed at 830 MPa

(a) LIST70 showing surface damage. Arrows point to secondary cracks

(b) LIST70 (830 MPa)

(c) Diagram showing fracture surface. Arrows point to the shaded areas representing SCC, the remaining surface shows ductile failure.

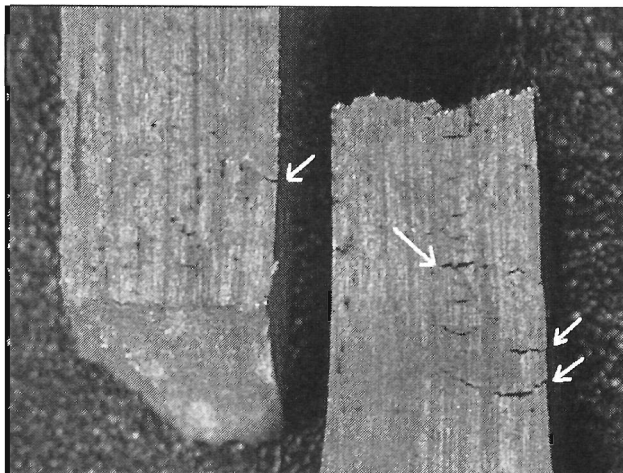
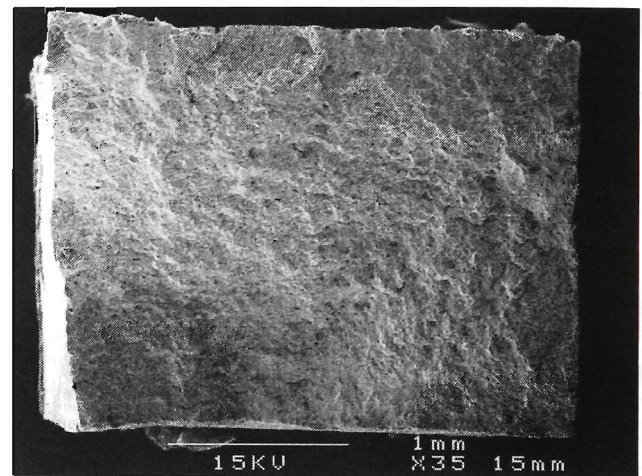
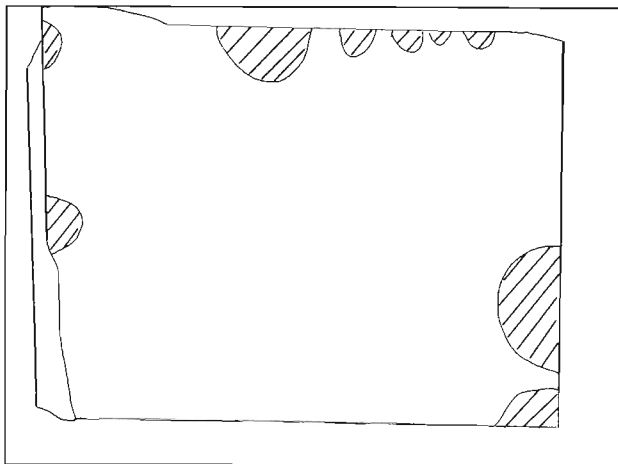
FIGURE 7.4: MA840B samples failed at 850 MPa

(a) LIST69 showing surface damage. Arrows point to secondary cracks

(b) LIST69 (850 MPa)

(c) Diagram showing fracture surface. Shaded regions represent subcritical SCC, the remaining surface showed ductile failure.

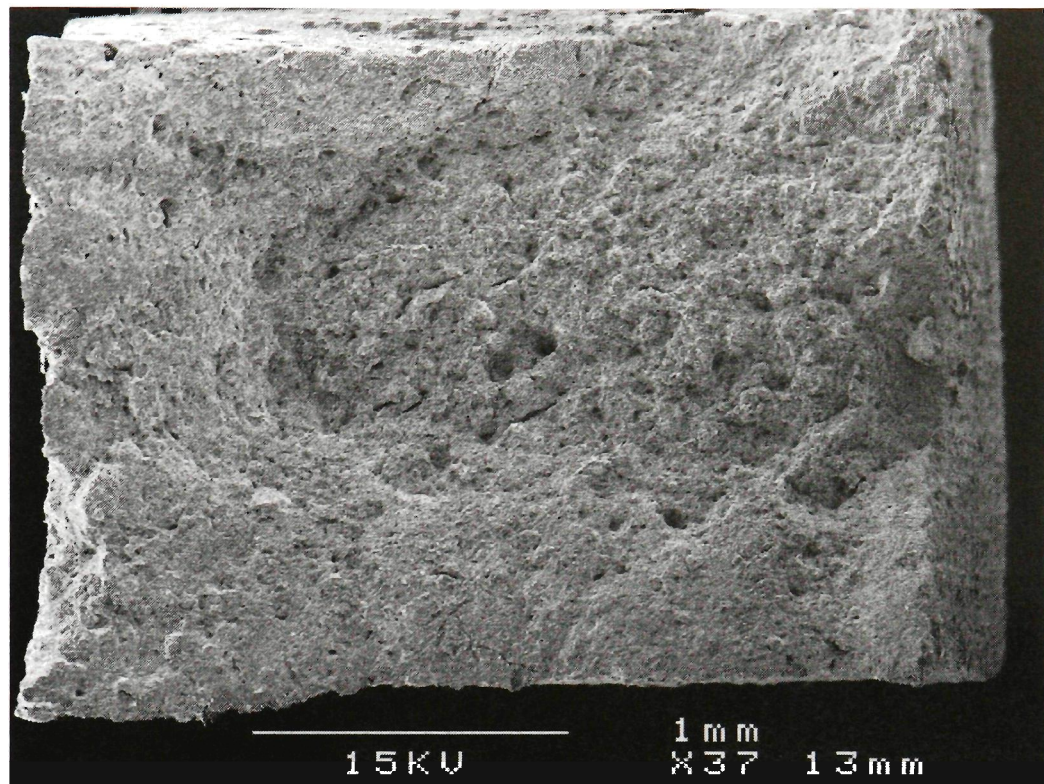
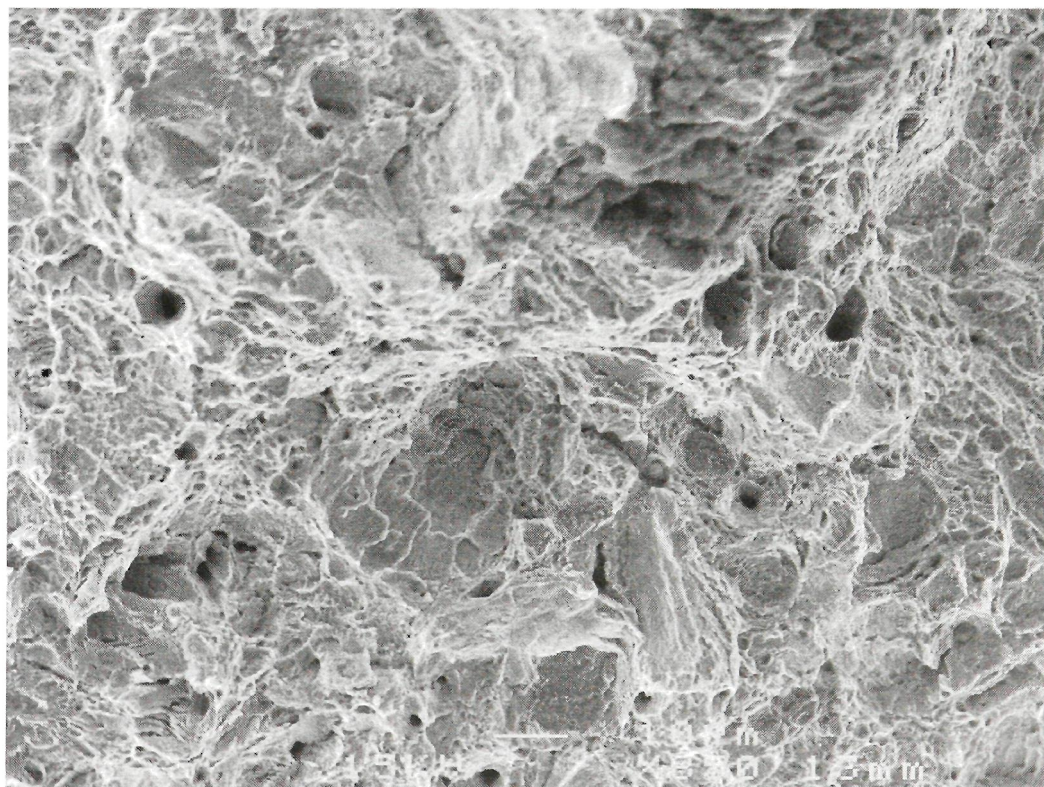
(a) Ductile failure (5152CW10D steel) LIST58

(b) Ductile failure in LIST58

FIGURE 7.5: Ductile failure (5152CW10D steel)

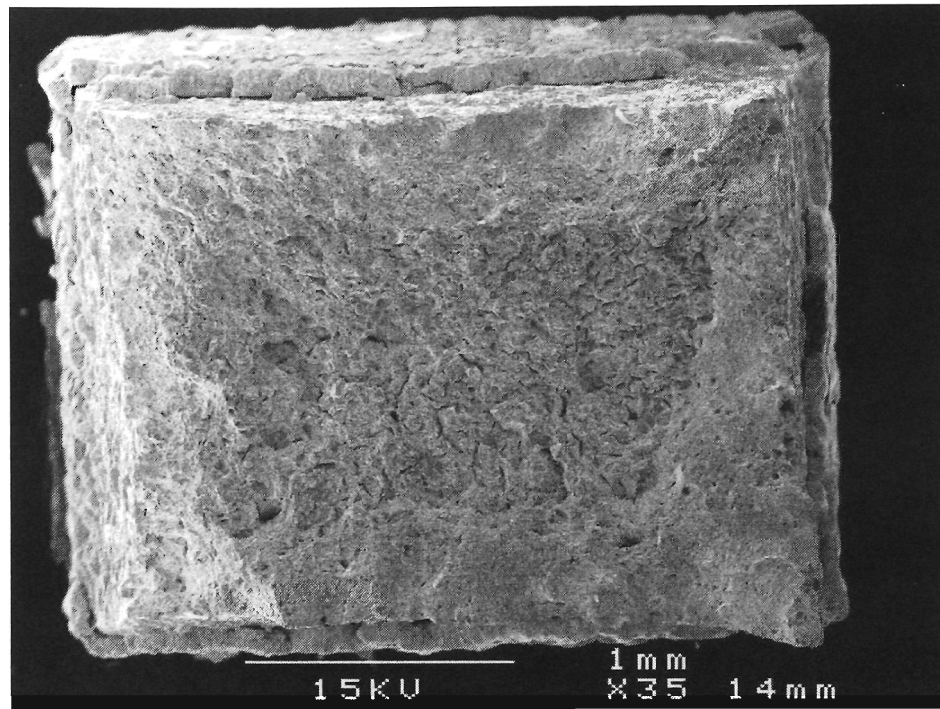
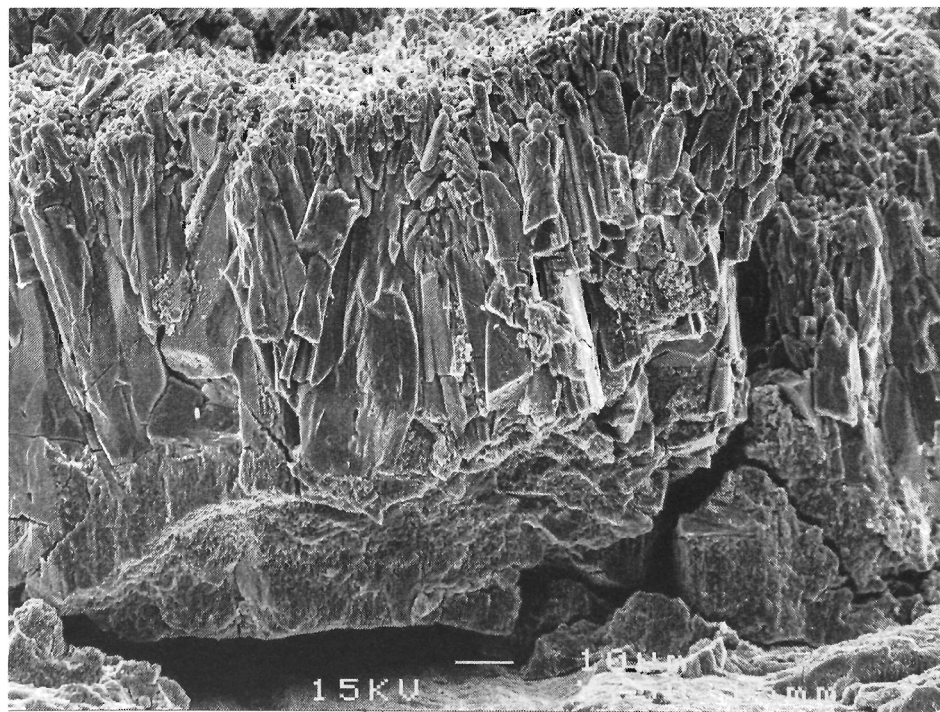
FIGURE 7.6: Galvanised LIST 1355AXRC sample

(a) LIST67 showing fracture surface

(b) LIST67 zinc layer

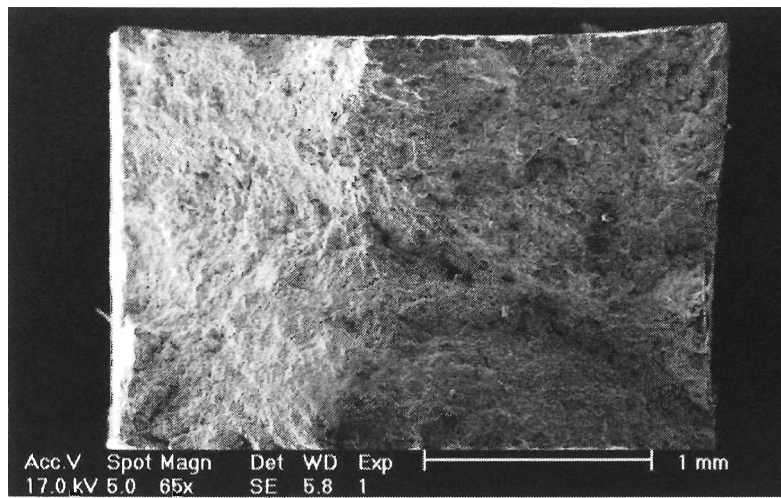
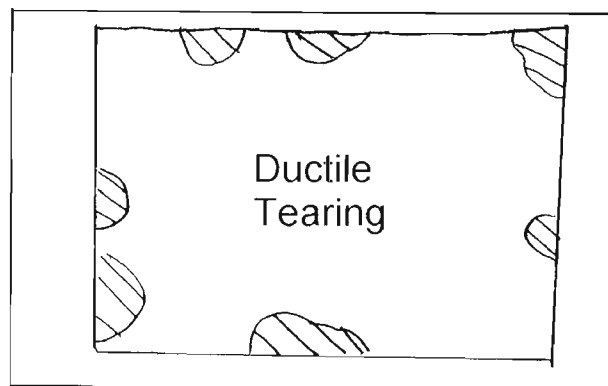
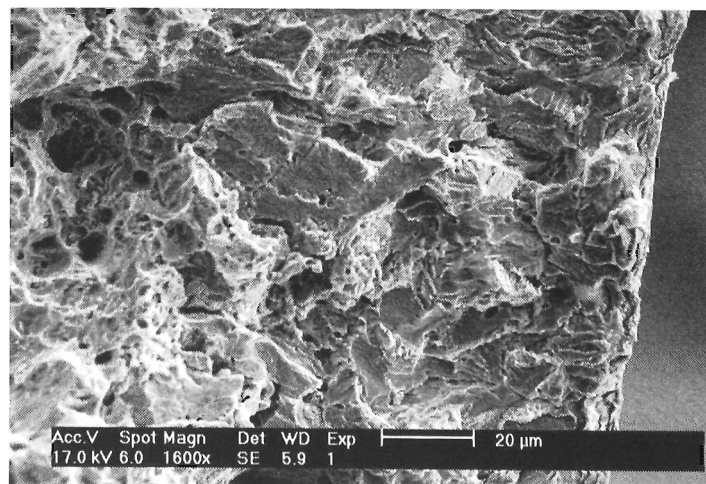
(a) Overview of LIST 102

(b) Diagram showing TTS (hashed areas) and ductile overload regions

(c) TTS showing pearlite colonies

FIGURE 7.8: 10M30 LIST sample failed by SCC

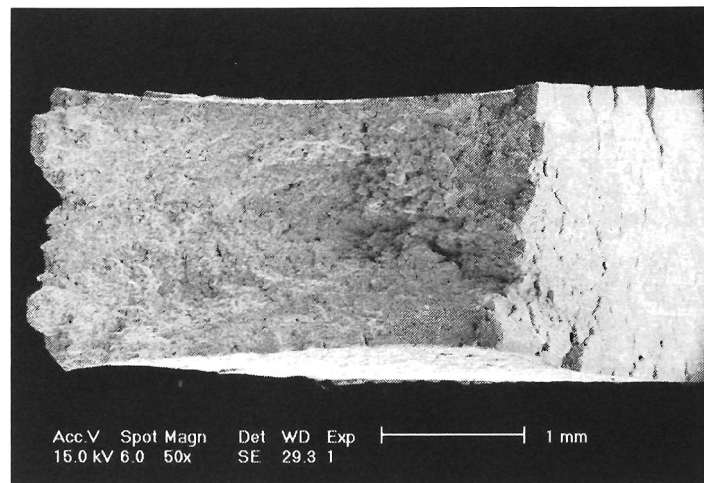
FIGURE 7.10: Overview of LIST 106

Figure 7.10 shows an overview of LIST 106. The macroscopic appearance was that of ductile tearing. Figure 7.11 shows a higher magnification of the right side of sample LIST 106. TTS can be seen on the edge, with CIS further in. Due to the lack of SCC of samples LIST 98 and 99, the evidence of SCC being displayed in LIST 102 and both kinds of fracture surfaces (ductile tearing and SCC) appearing on LIST 106 point to the fact that the environmental conditions of LIST 106 have reached the necessary pH and potential values for SCC to develop.

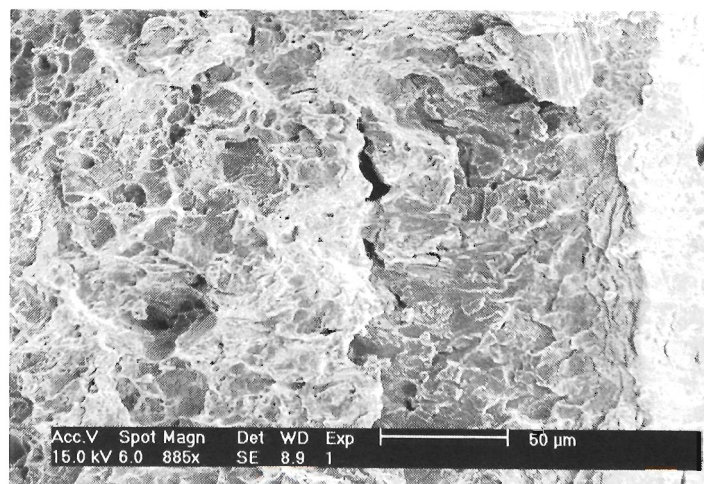
FIGURE 7.11: TTS and CIS within LIST 106

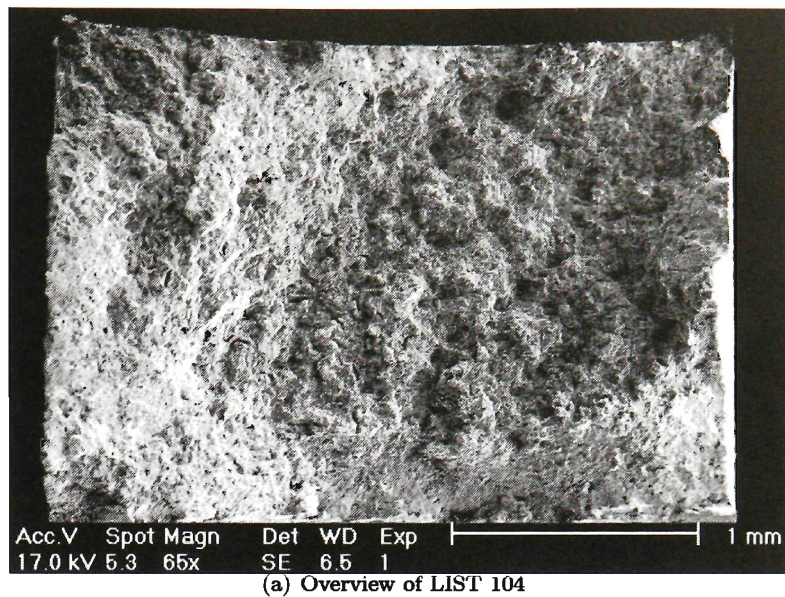
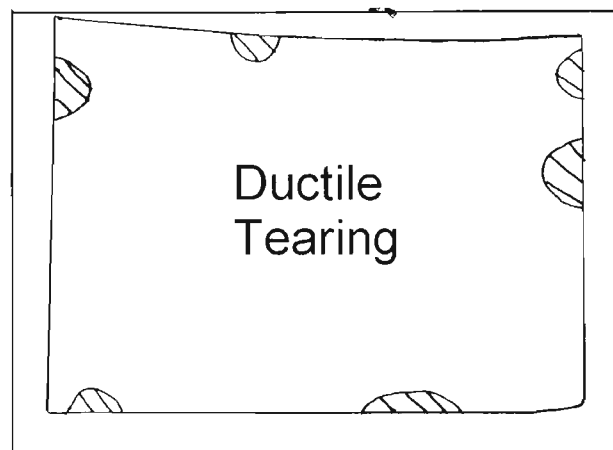
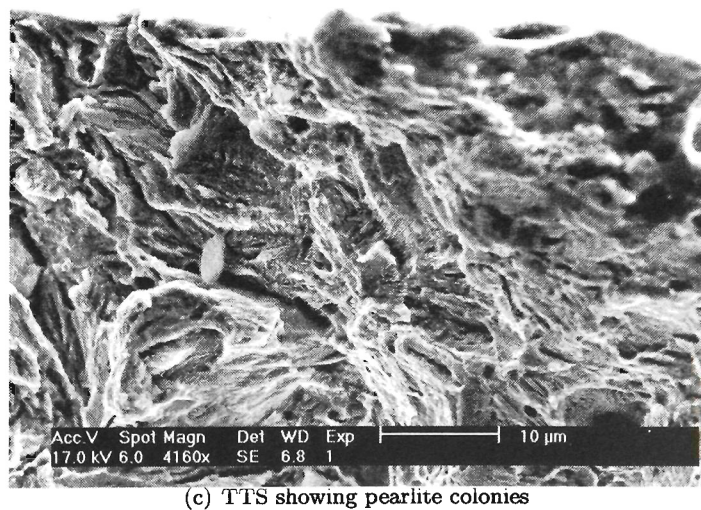
Figure 7.12 shows an 5152CW10D LIST sample failed by SCC. Figure 7.12(a) shows an overview of the LIST sample, and Figure 7.12(c) shows the TTS of one of the initiation sites. Figure 7.12(c) shows in detail the pearlite colonies, and how the crack advanced through the material irrespective of the microstructure (shown by the varied orientation of pearlite lamella). There were no CIS or qMVC regions on the fracture surface. This was postulated to be due to a low diffusion velocity of hydrogen through the material. Even though prior to fracture there was a considerable amount of hydrogen being evolved on the surface, very little of that hydrogen was able to enter the material, embrittling it in the process.

FIGURE 7.12: 5152CW10D LIST sample failed by SCC
